Subject: Information Report, NHTSA No. 98V-22~~1~~³

Subject: XC Side Radiator Hydraulic System
FL243AD U.S.
FC243AD Canada

January 2000
FL243AD U.S.
FC243AD Canada

Subject: XC Side Radiator Hydraulic System

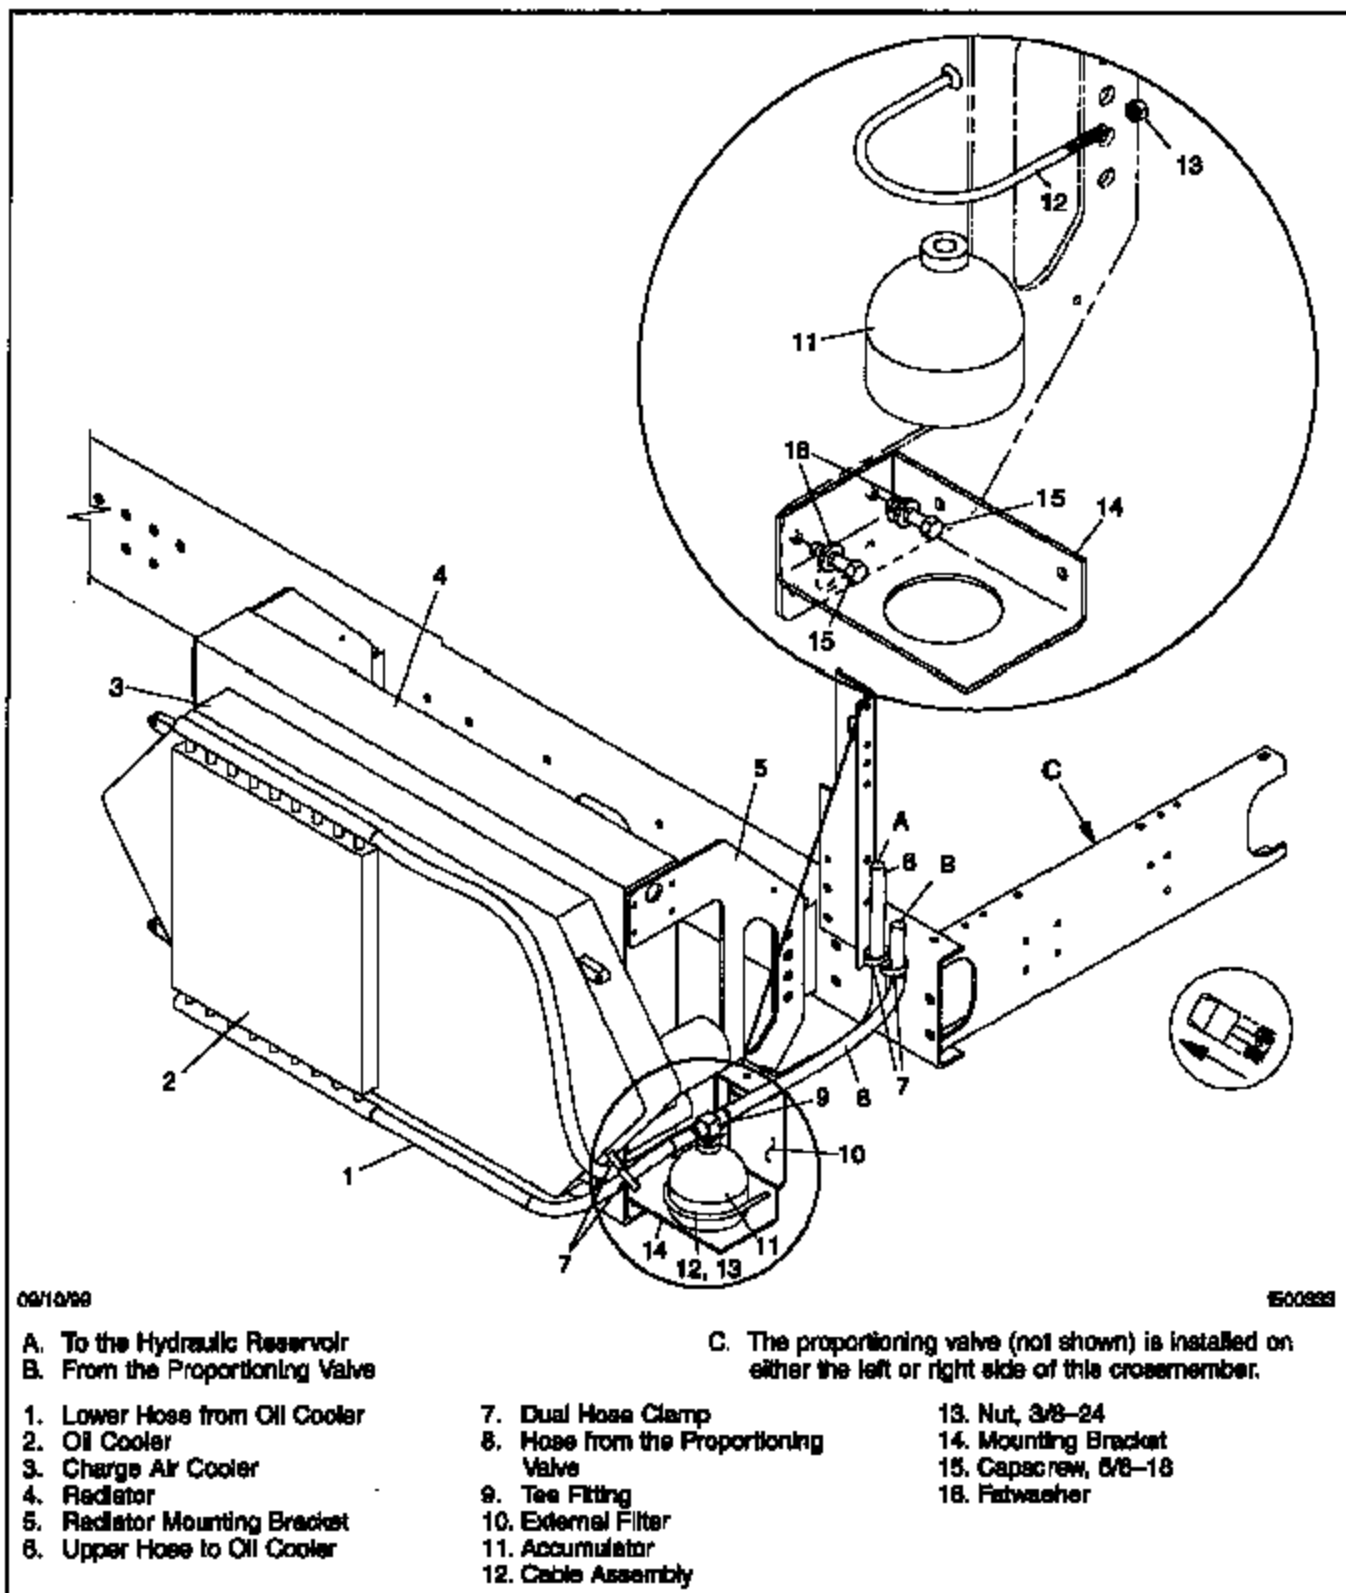
Fig. 1, Installation of Hydraulic System Accumulator

The filter gasket for the power steering hydraulic fluid may blow out due to pressure spikes in the system. This can result in a loss of power steering fluid and an eventual loss of power assist to the steering if the leak is undetected. The vehicle will retain mechanical steering capability.

The modification consists of adding an accumulator to the hydraulic system on all vehicles. The external filter should also be removed from vehicles equipped with a metal hydraulic fluid reservoir.

4. Put a clean container under the power steering reservoir and disconnect the supply hose from the reservoir to drain the system.
5. Disconnect and remove the hose connecting the proportioning valve to the lower end of the oil cooler. See Fig. 1.

8. Install the Tee-fitting onto the accumulator and tighten 20 lbf-ft (27 N-m).
9. Seat the accumulator onto the mounting bracket. See Fig. 1.
10. Using the cable assembly and the 3/8-24 nut, secure the accumulator to the bracket. See Fig. 1. Tighten the nut 30 lbf-ft (40 N-m).

13. Using two dual hose clamps, secure the hoses together. See Fig. 1.
14. Check the type of power steering reservoir.

If equipped with a 12-quart metal reservoir, check for an external filter near the oil cooler, in the hydraulic hose running from the top of the oil cooler to the reservoir. See Fig. 1.

If the filter is present, remove it and connect the hose ends using a union fitting from the kit. Tighten the fittings 20 lbf-ft (27 N-m).

IMPORTANT: Remove the external filter *only* if equipped with a metal reservoir. If the vehicle is equipped with a plastic reservoir, do not remove the external filter; leave it in place.

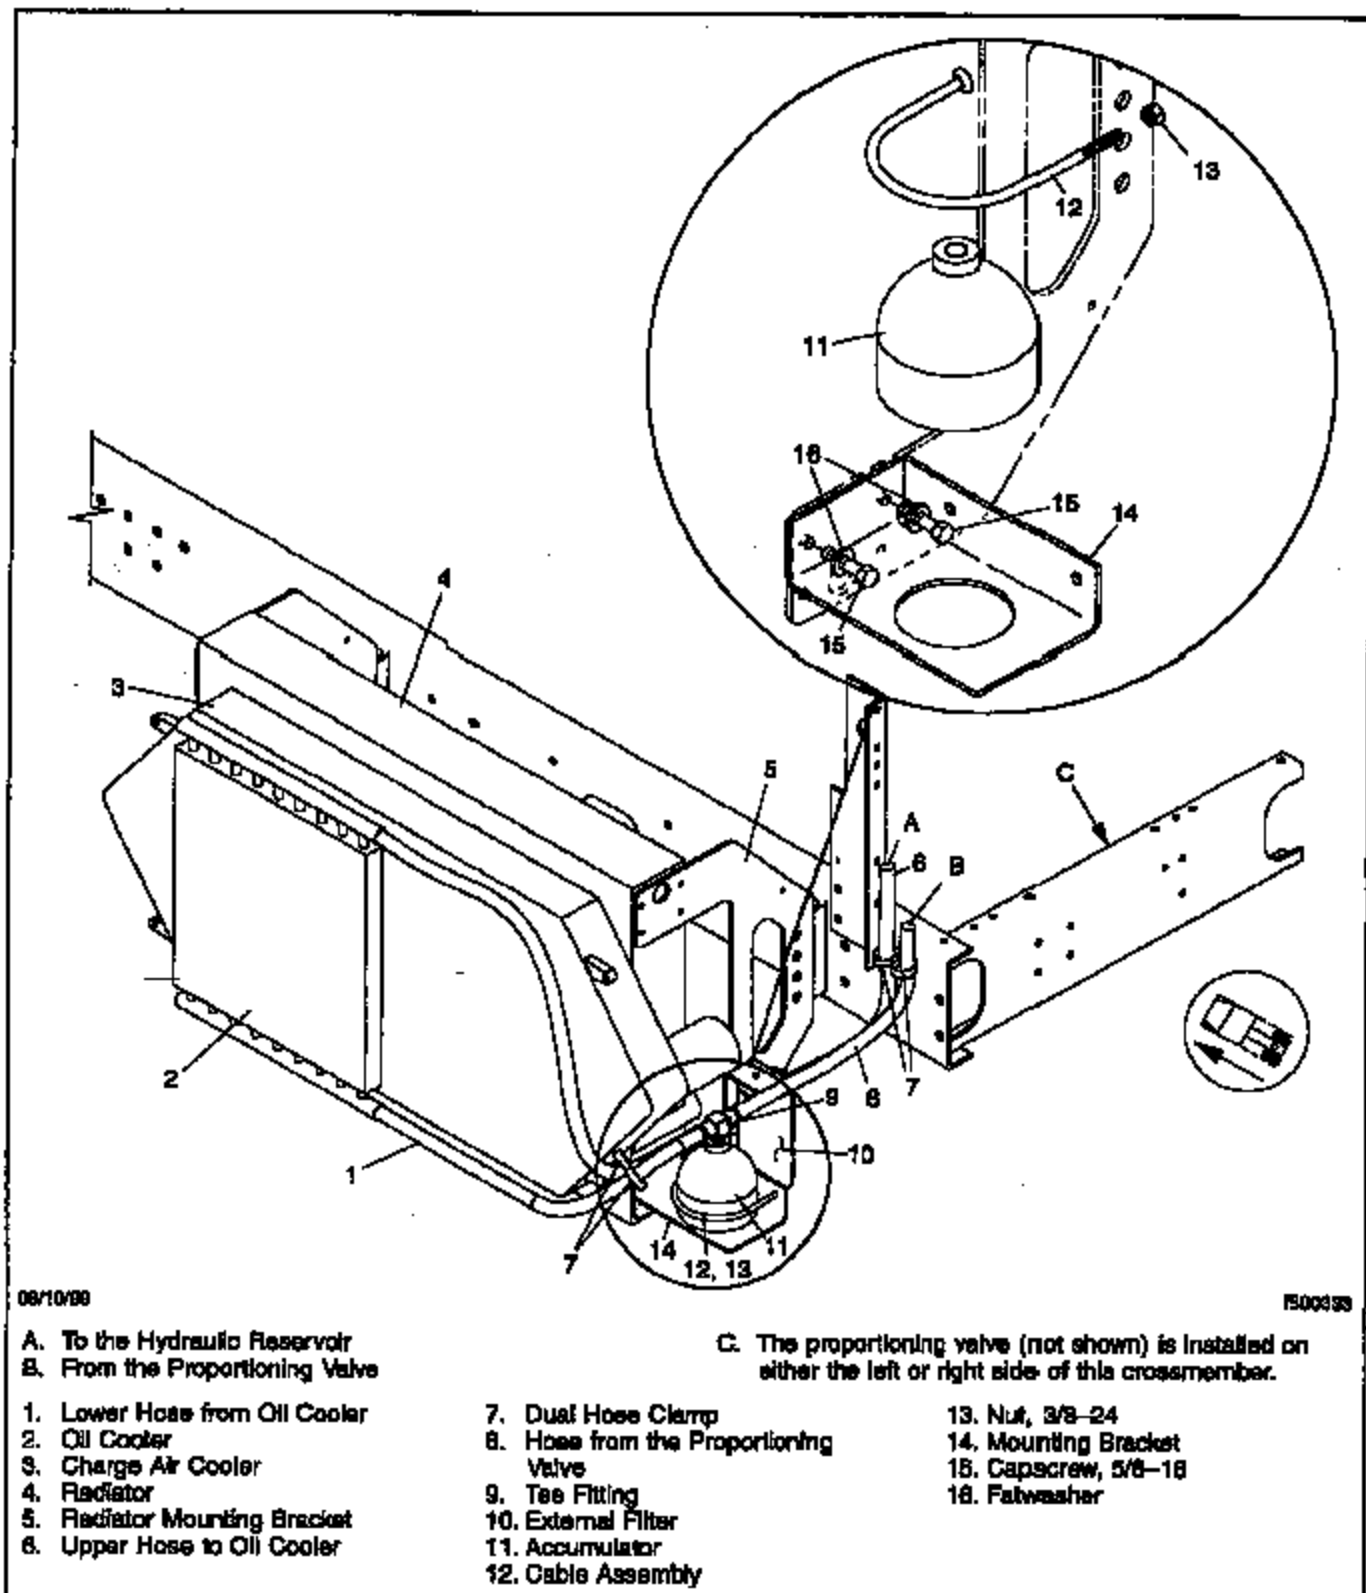
Fig. 1, Installation of Hydraulic System Accumulator

The filter gasket for the power steering hydraulic fluid may blow out due to pressure spikes in the system. This can result in a loss of power steering fluid and an eventual loss of power assist to the steering if the leak is undetected. The vehicle will retain mechanical steering capability.

The modification consists of adding an accumulator to the hydraulic system on all vehicles. The external filter should also be removed from vehicles equipped with a metal hydraulic fluid reservoir.
